Manhole Inspection Summary

Manhole # S39E__031MH

Location Address: **832 E Baltimore st**

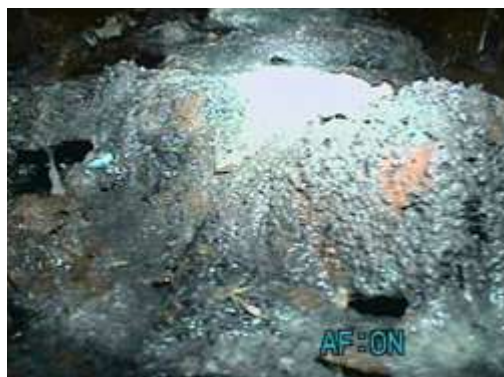
Defect 4

Condition: ☐ Sound ☐ Cracked ☐ Root Intrusion ☐ Deteriorated ☐ Leaks ☒ **Debris**

bench debris

channel debris

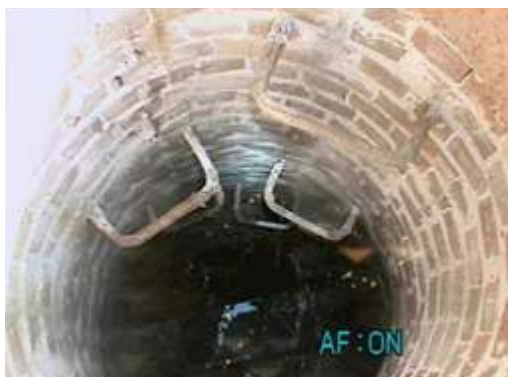
Defect 3

Steps Count: **5** Missing: **0** ☒ **Corroded**

corroded steps

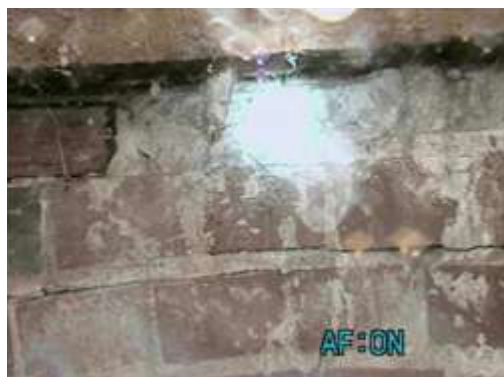
Defect 2

Condition: ☐ Sound ☒ **Cracked** ☐ Root Intrusion ☒ **Loose Brick** ☐ Deteriorated

deteriorated and loose brick in corbel

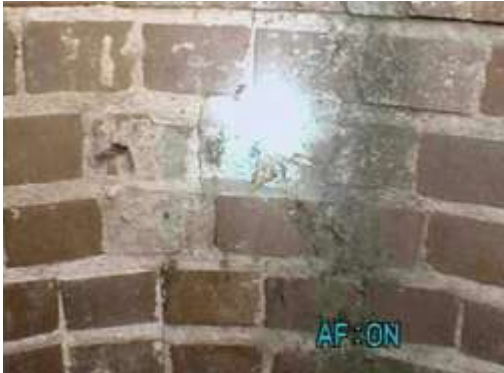
Defect 1

Condition: ☐ Sound ☒ **Cracked** ☐ Root Intrusion ☐ Loose Brick ☐ Deteriorated

Infiltration: ☐ None ☐ Joint ☐ Cracks ☐ Mortar ☐ Roots ☒ **Wall**

crack barrel, signs of infiltration on wall of barrel

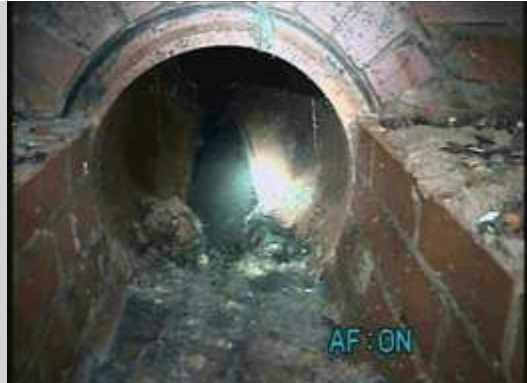
12 O'Clock Outflow

10 in. Circular Gravity Sewer
Pipe Out @ 12 O'Clock

Deposits: ☐ None ☐ Mud ☒ **Sludge** ☐ **Debris** ☐ Grease

Silt Depth: 2 (in.) Deposits Extent: **Light**

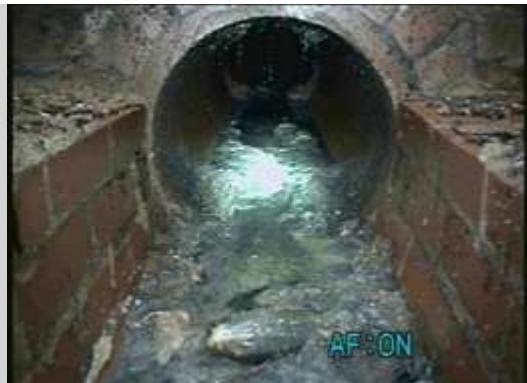
6 O'Clock Inflow

10 in. Circular Gravity Sewer
Pipe In @ 6 O'Clock

Deposits: ☐ None ☐ Mud ☐ Sludge ☒ **Debris** ☐ Grease

Silt Depth: 2 (in.) Deposits Extent: **Medium**
